Re: **Mold Testing and Assessment**

[REDACTED]  
AAB Project #: 225-066

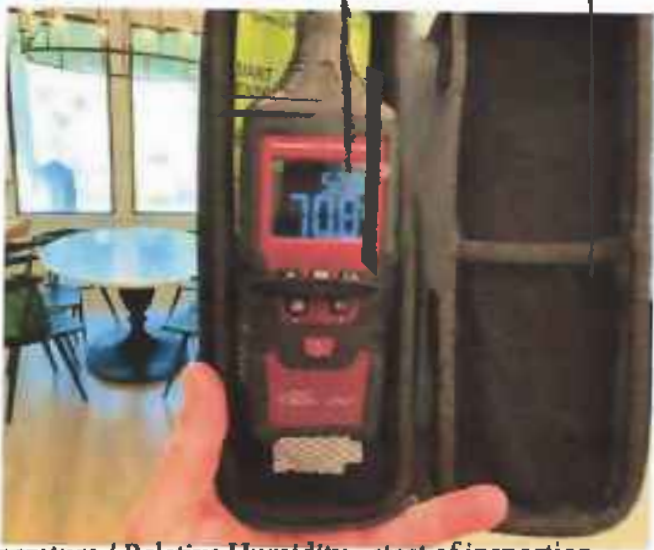
6. **Relative Humidity and Temperature:** At the time of AAB inspection, relative humidity readings collected within the structure fell within a normal range of 50% to 52%. Note: The thermostat was set to 73 degrees with the system set to auto. See the attached photos.

Temperature / Relative Humidity - start of inspection

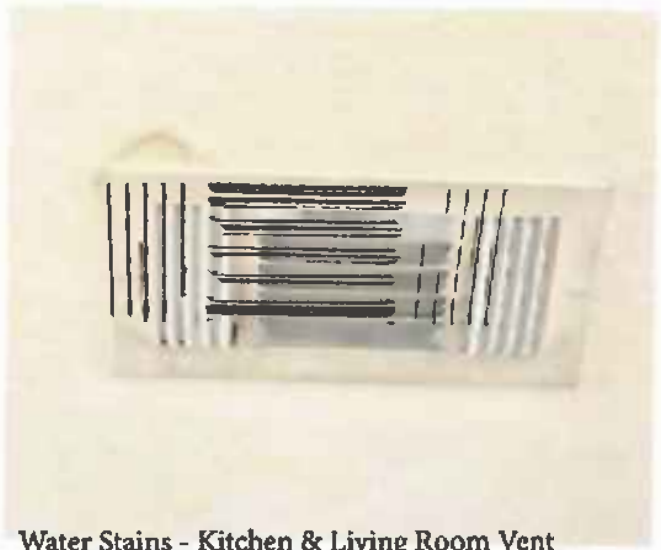
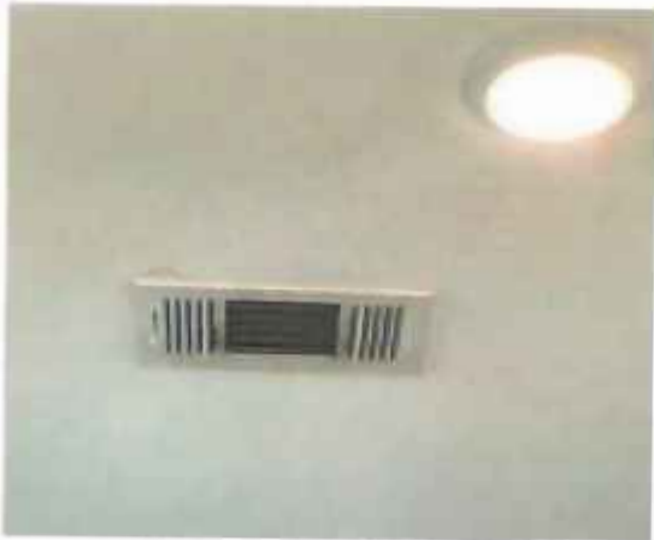
2. **AAB Inspection:** At the time of AAB's inspection, mold growth/water damage was observed at the master bathroom vent cover/toilet water supply area, utility room vent cover, kitchen vent area and other multiple vent covers. Moisture content readings were collected from these areas; the observed readings fell within a normal range of 0 to 12%. The most likely cause of the observed stains, damage (trim movement) and mold growth is the improper usage of the HVAC system. As reported in the H5 report, the combination of the low temperature settings (65 degrees) and the HVAC fan set to the "On" position is the most likely cause of the observed damage/growth. See the attached photos.

Water Stains - Kitchen & Living Room Vent

- **All Vents (Master Bathroom, Utility and Kitchen Vent Hood):** Remove the vent covers and clean. Remove all mold affected ceiling wall sheet. Clean the vent ductwork as needed. Remove the water damage trim adjacent to the kitchen vent hood.

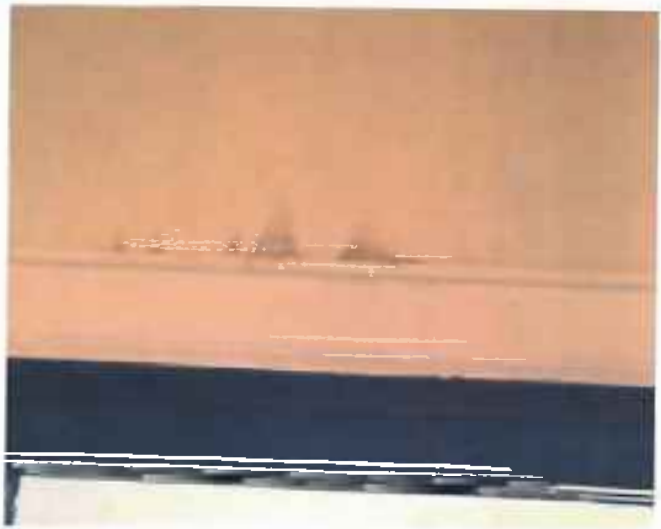
4. **Exterior Doorways:** At the time of AAB's inspection, mold growth was observed on wall sheet rock adjacent to multiple exterior doorways (garage, main entry and back doors). The most likely cause of the observed stains, damage (trim movement) and mold growth is the improper usage of the HVAC system (as documented in the E5 report). Moisture content readings were collected from these areas; the observed readings fell within a normal range of 0 to 12%. The combination of the low temperature settings (65 degrees) and the HVAC fan set to the "On" position is the most likely cause of the observed damage/growth. See the attached photos.

Exterior Door Trim

- **Exterior Doorways:** Pull the interior trim and inspect the newly exposed wall sheet rock. If mold growth is observed - remove the wall sheet rock until clean materials are observed (approximately 1 foot in all directions).

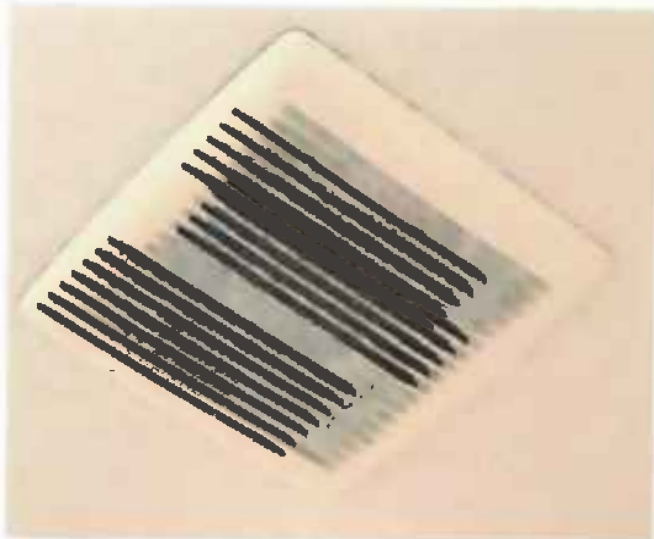
Utility Room Vent

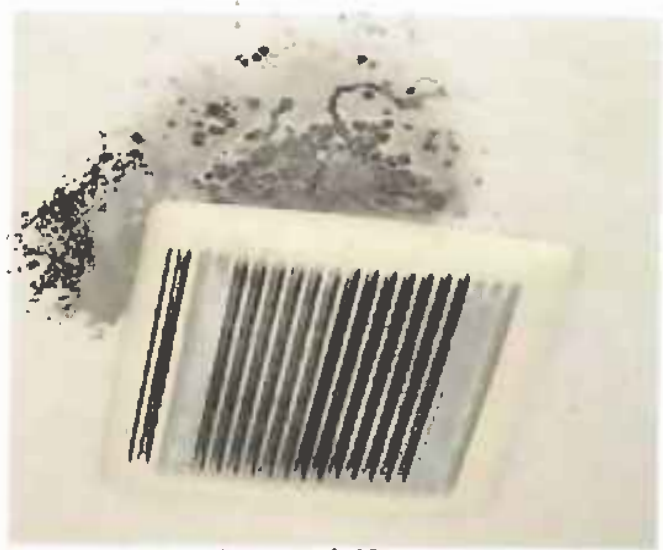
Master Bath Vent

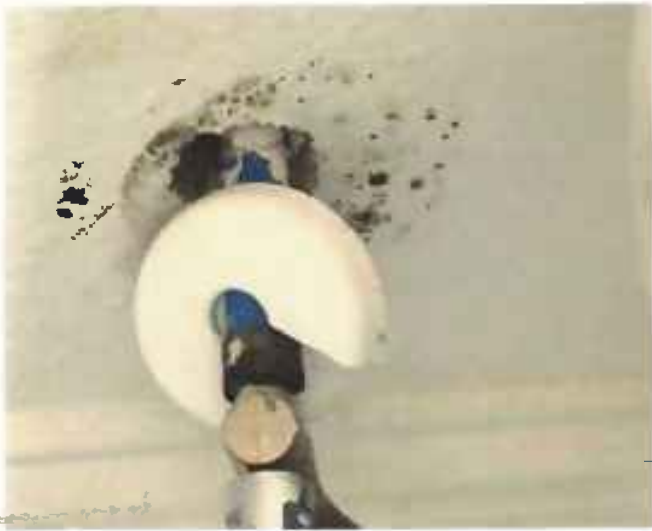
Master Bath Water Supply

- **Master Toilet Area:** Remove the wall sheet rock adjacent to the water supply line.
- **Other Areas:** Inspect the remaining plumbing penetration areas (vanities, kitchen and toilet areas). If mold affected wall sheet rock are observed, removed additional wall materials adjacent to the penetration covers.

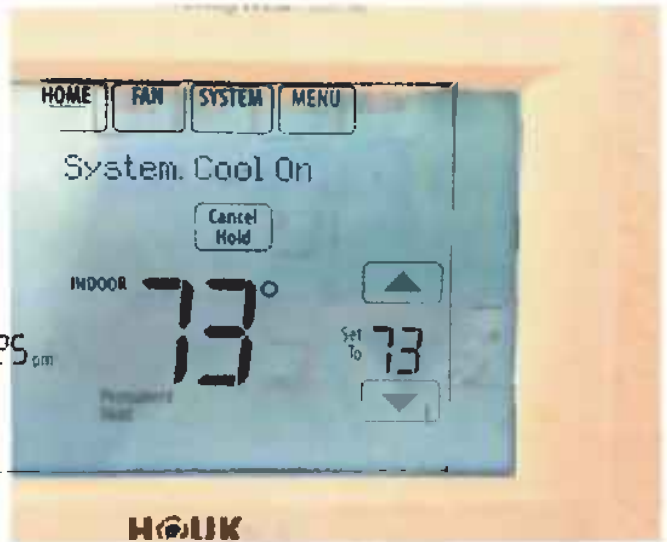
Thermostat Setting

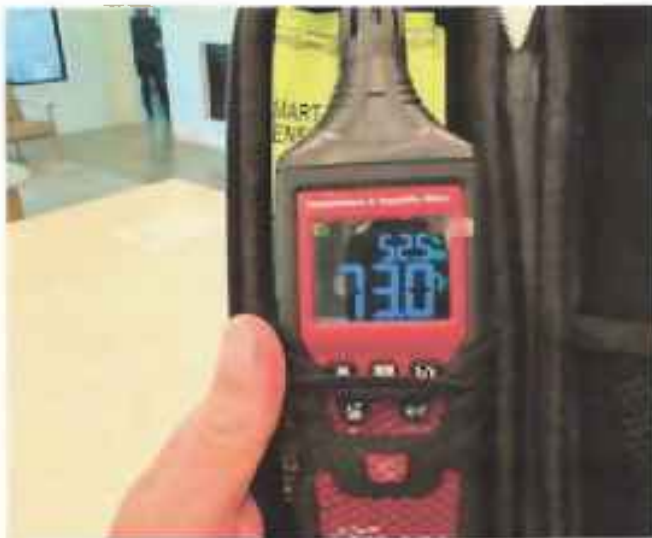
Temperature & Relative Humidity - End

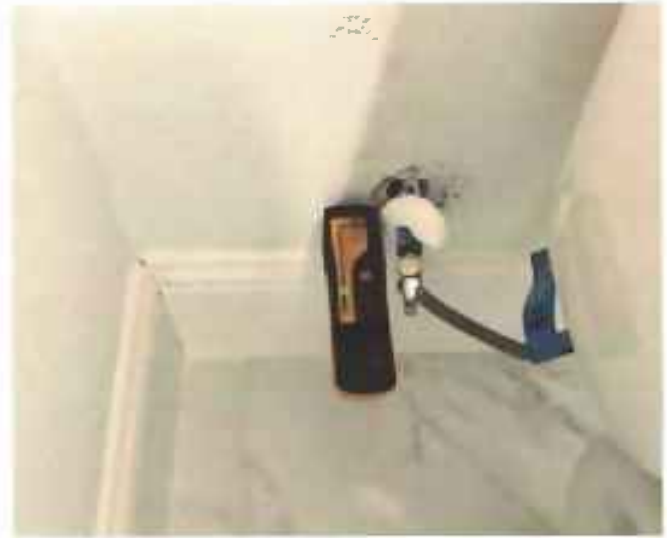
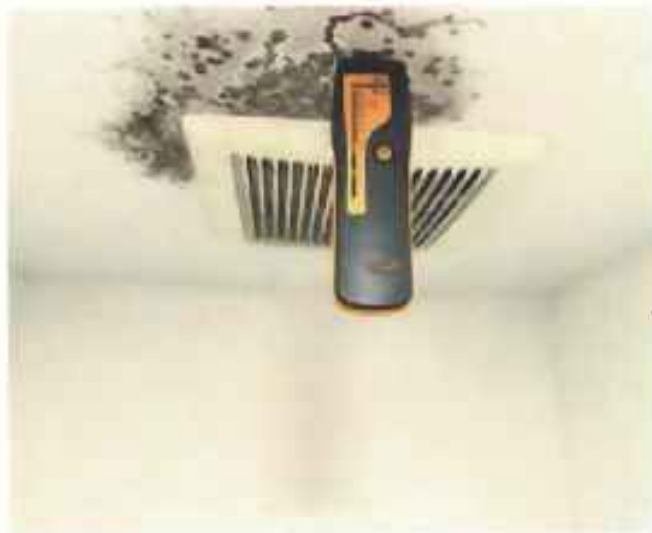
Normal Moisture Content - Master Bath

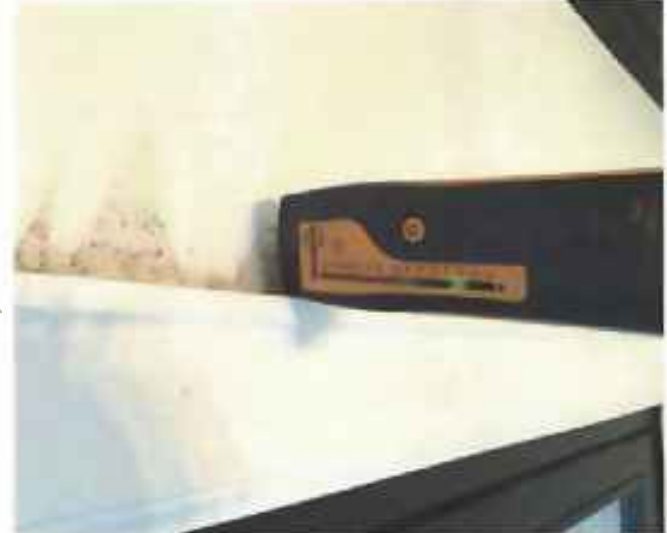
Normal Moisture Content - Exterior Door Trim

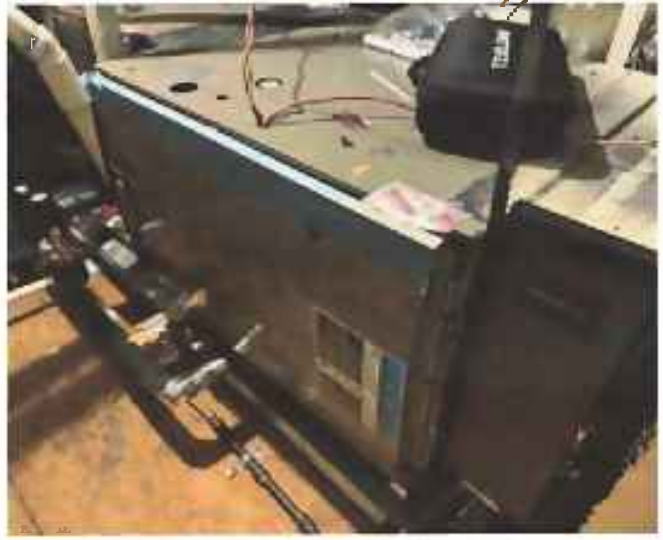
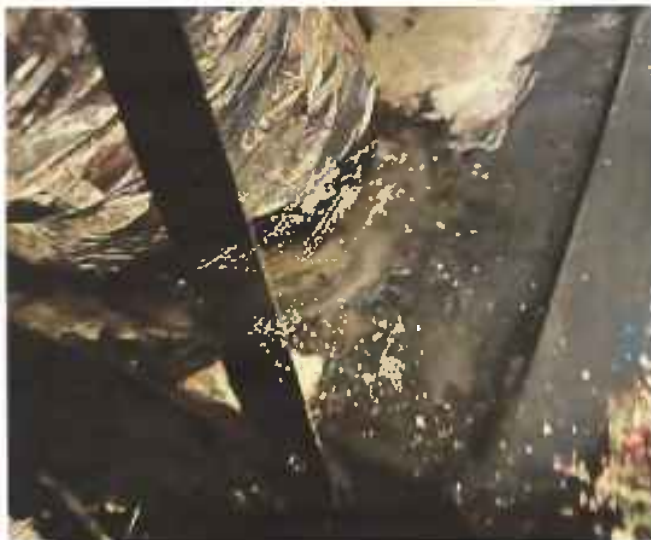
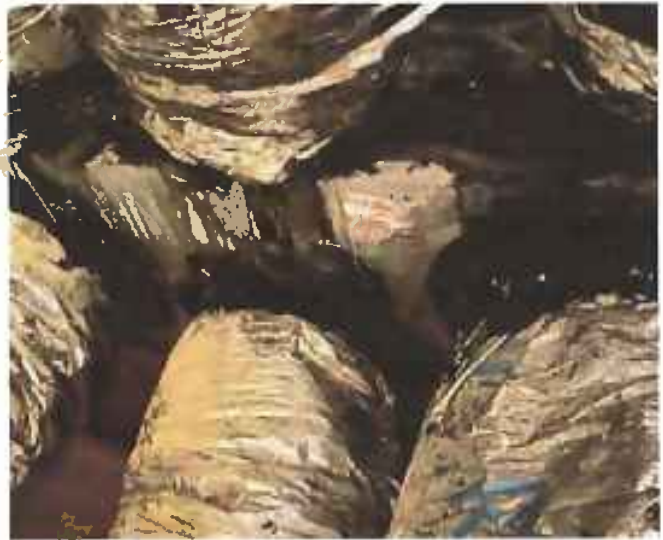
**Typical Conditions - HVAC System**

3. **Attic HVAC System/dehumidification equipment:** At the time of AAB's inspection, the interiors of the HVAC blower unit/plenums were visually inspected; no significant mold growth was observed. The interior of the dehumidification equipment was visually inspected. No significant mold growth was observed. See the attached photos.

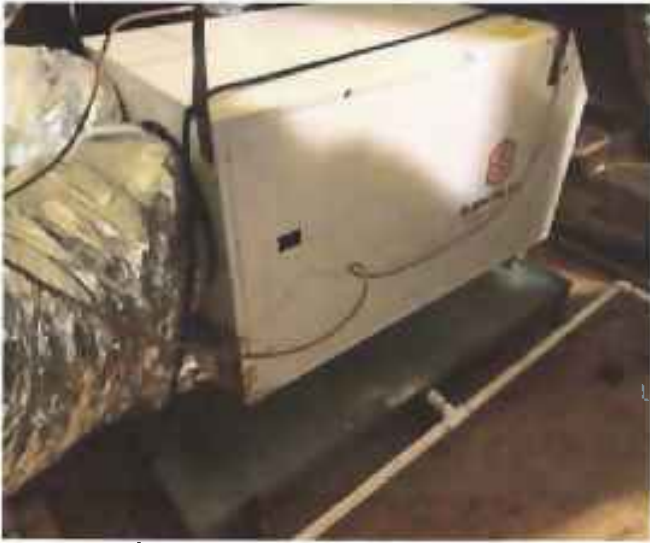
Typical Conditions - Dehumidifier

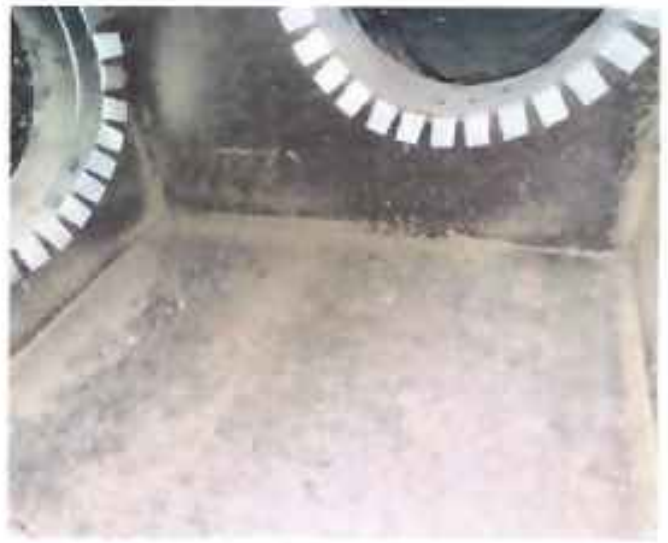
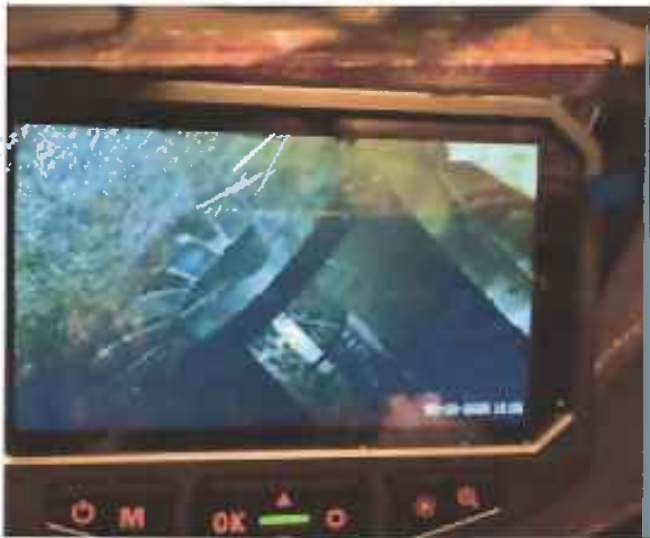
Plenum - HVAC

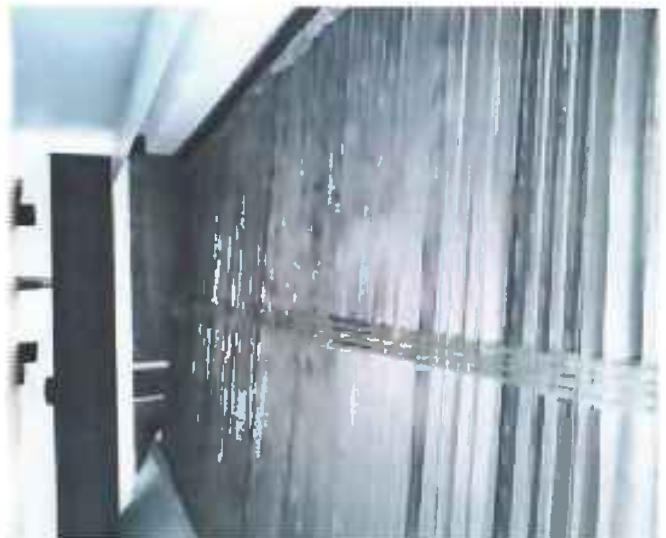
Interior - Dehumidifier

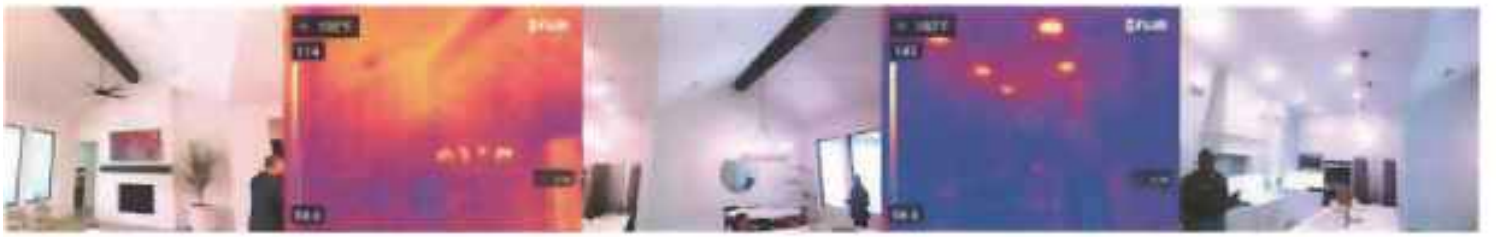
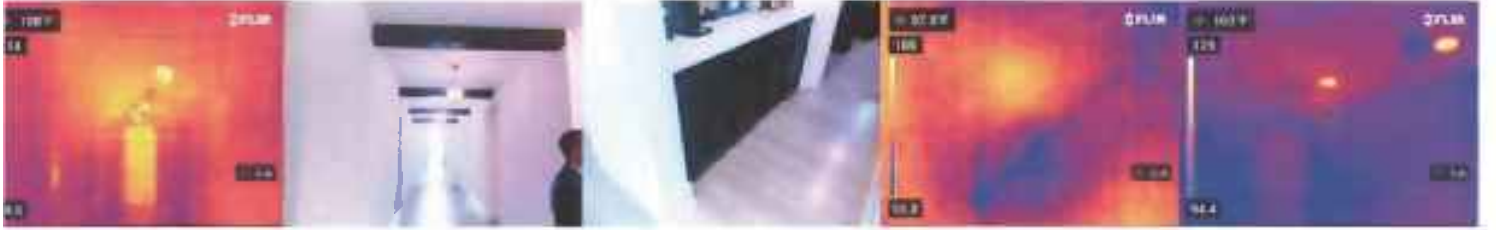
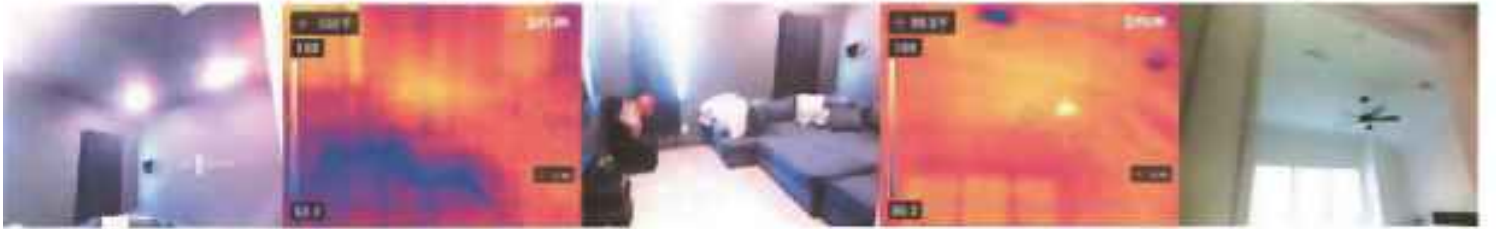
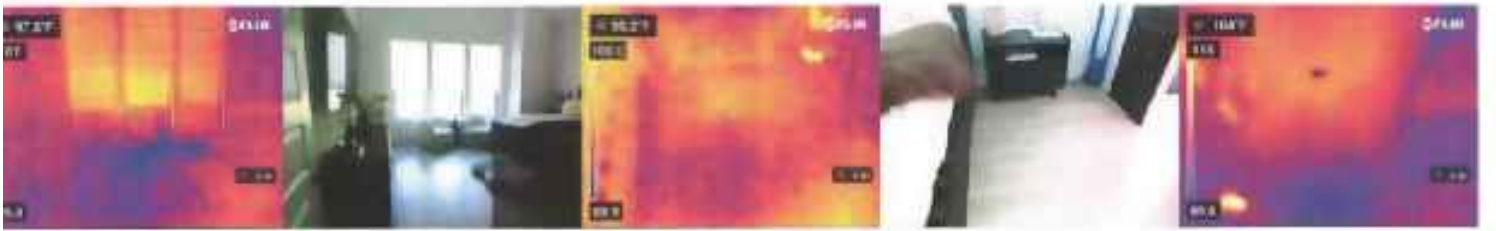
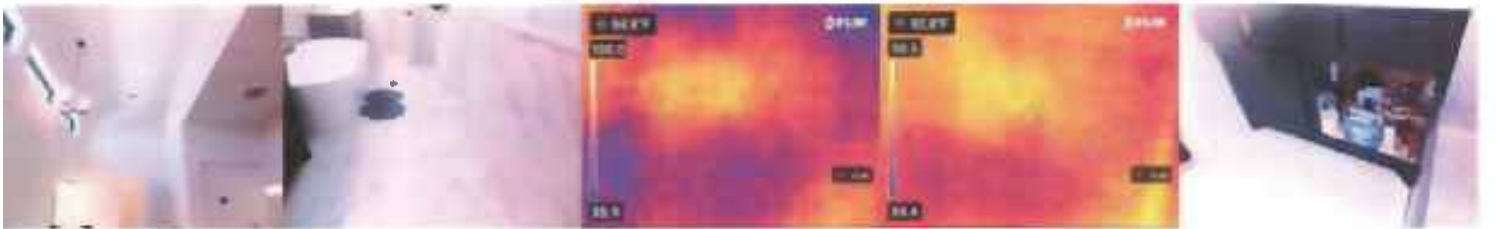
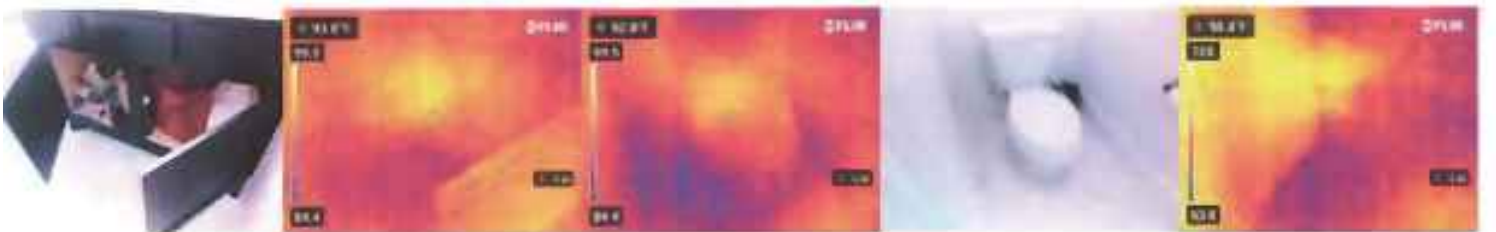
## IR Images

5. **IR Scans:** AAB scanned all of the interior surfaces with an FLIR C-5 IR camera, no significant temperature abnormalities (potential wet areas) were observed in the images of the structure.
