**Stephen Bourne, Ph.D.**  
**Building Research LLC**  
**PO Box 1188, Crystal Bay NV 89402**

04/15/2025

## **Scope**

Building Research LLC (BRLLC) has been asked to develop a preliminary report for the residence at [REDACTED]. BRLLC visited this home as part of an investigative team on April 4, 2025. The scope of this preliminary report is limited to addressing concerns regarding the building envelope and HVAC systems.

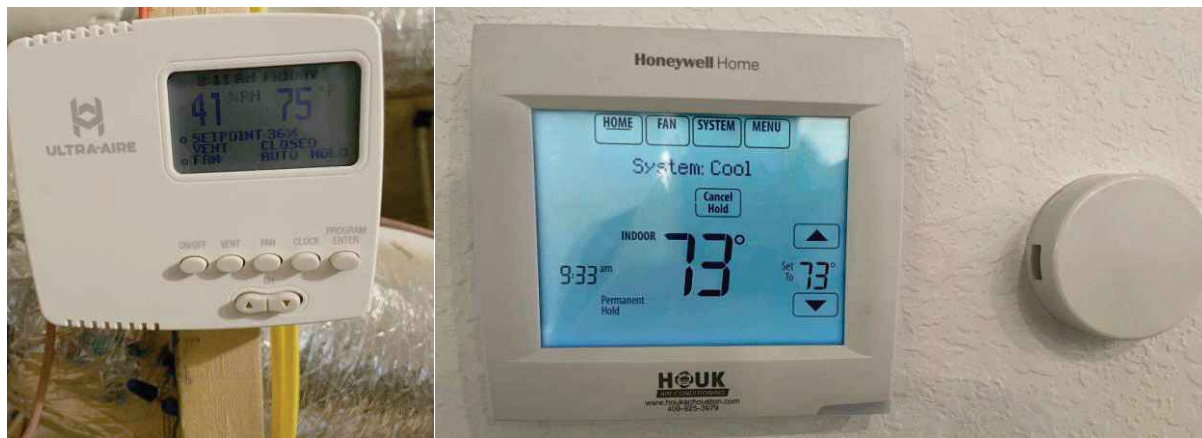
An Ultra-Aire XT155H dehumidifier (Table 5) is installed in the attic and plumbed to the occupied space, the HVAC system and a fresh air inlet. It is controlled by a separate humidistat controller and humidity sensor; the humidity sensor is installed next to the thermostat while the controller itself is installed in the sealed attic along with the dehumidifier and HVAC system (Figure 1).

**Figure 1:** On the left: the attic-mounted DEH3000R humidistat; on the right, the thermostat and humidity sensor. The round humidity sensor is wired directly to the DEH3000R controller.

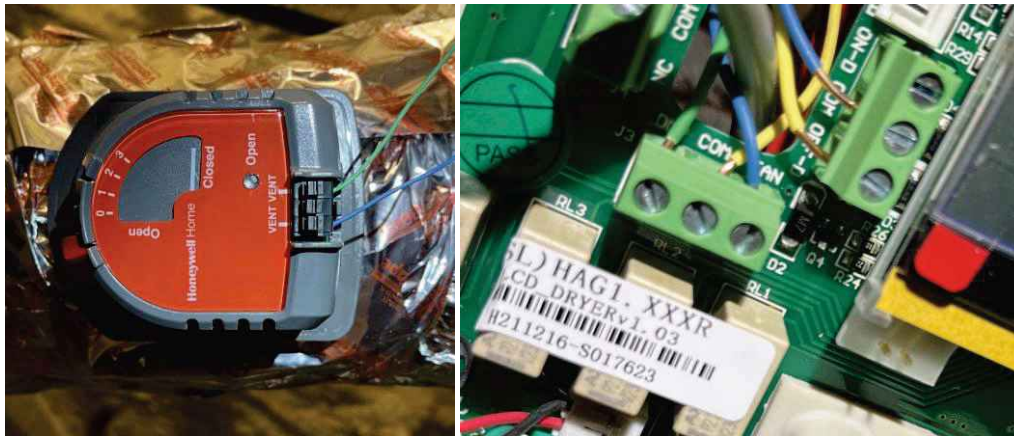
**Figure 2:** The fresh air damper on the right is using the green and blue wires; these are wired to the DMP and FAN terminals on the DE3000R controller, effectively disabling the fresh air damper.

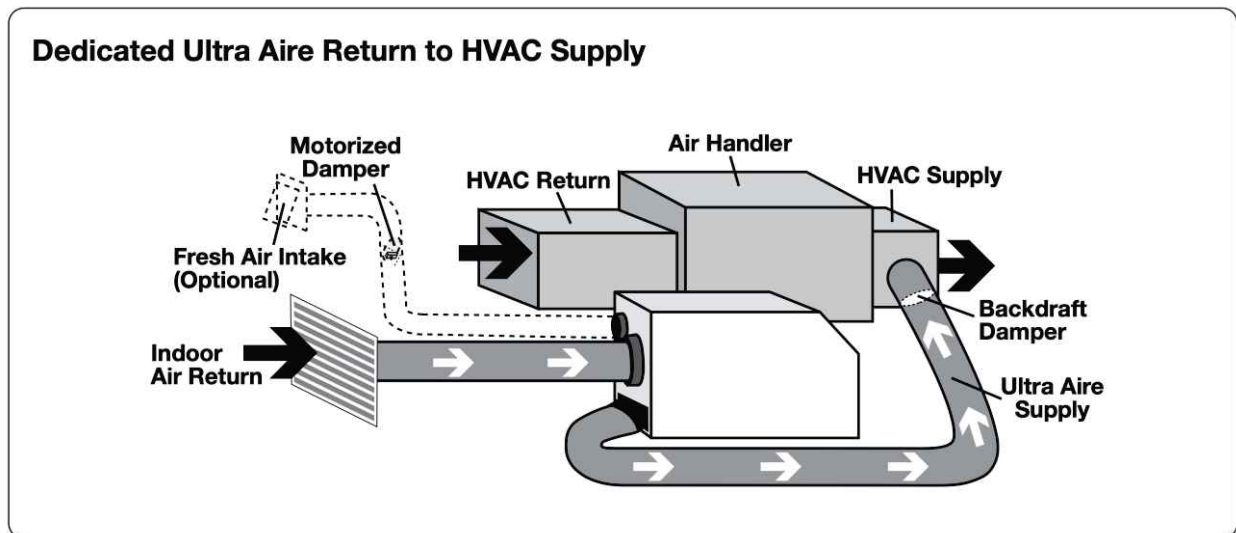
The supply and return of the dehumidifier are unconventionally ducted; the installation does not match the recommendation provided in the manufacturer’s installation guide<sup>6</sup>, although the recommendation is not mandatory. The manufacturer’s recommended installation is shown in Figure 3.

**Figure 3:** The manufacturer recommended installation for the dehumidifier. In the installation at this home the return and supply duct connections have been reversed.

As installed, the supply and return duct connections are reversed. While this ducting may temporarily impact thermal comfort near the dehumidifier discharge at the powder bath alcove between HVAC system cycles (a complaint voiced by the homeowner in the 2025 CDC report), it will have no impact on the overall performance of the dehumidifier when operating.

A backdraft damper is installed at the location shown in Figure 3; however, its direction is reversed by necessity (the dehumidifier would not function as plumbed if the backdraft damper were not reversed). One impact of this is that some air from the supply plenum is routed through the dehumidifier to be exhausted at the powder bath alcove when the HVAC system runs. This will help distribute the warm, dry air exhausted here by the dehumidifier and aid in its distribution throughout the home. However, the operating pressures of the supply plenum are very low (0.03 inWC; see Table 2), which will limit this air flow.

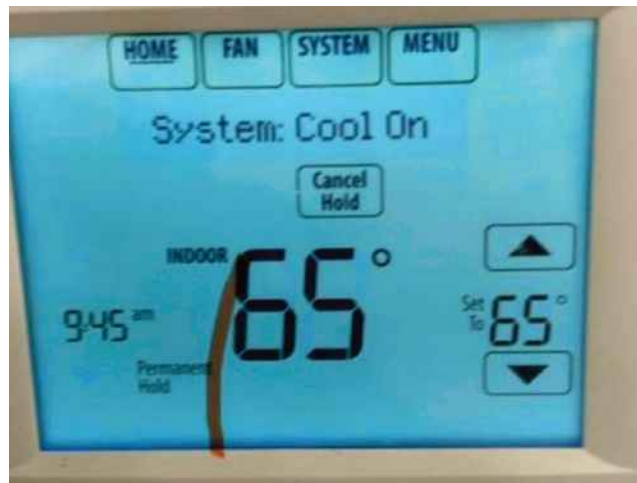
Photographs<sup>18</sup> (ostensibly from the homeowner) dated 5/28/24 show the HVAC system set to and holding 68°F – fully 7°F below the design set point of 75°F. Other photographs from the homeowner<sup>19</sup> dated 5/30/24 show the HVAC system being operated at a set point temperature of 66°F (confirmed in the associated email as an intentional temperature setting). Still others<sup>20</sup> dated 5/31/24 show the thermostat set for and holding 65°F (Figure 9).

**Figure 9:** A photograph, ostensibly from the homeowner and dated 5/31/2024, showing the thermostat set to (and holding) a permanent temperature setting of 65°F.

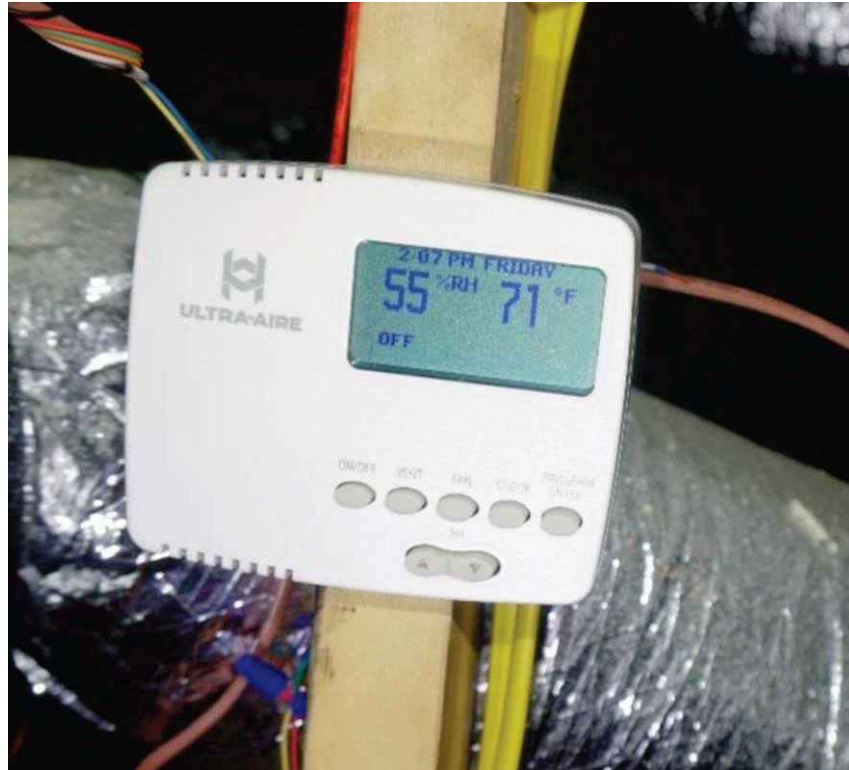
Photos contained in the 2025 CDC report show the thermostat set to and holding 68°F on 6/21/24; this is also confirmed in the text of the CDC report. This report also compares the thermostat readings to a “calibrated meter”, indicating that the temperature shown on the thermostat is very close to the actual reading. The CDC report also notes that the dehumidifier was turned off at the time of their inspection (Figure 10).

**Figure 10:** This photo excerpt from the 2025 CDC report shows that the dehumidifier has been turned off. This was confirmed in the text of the CDC report.

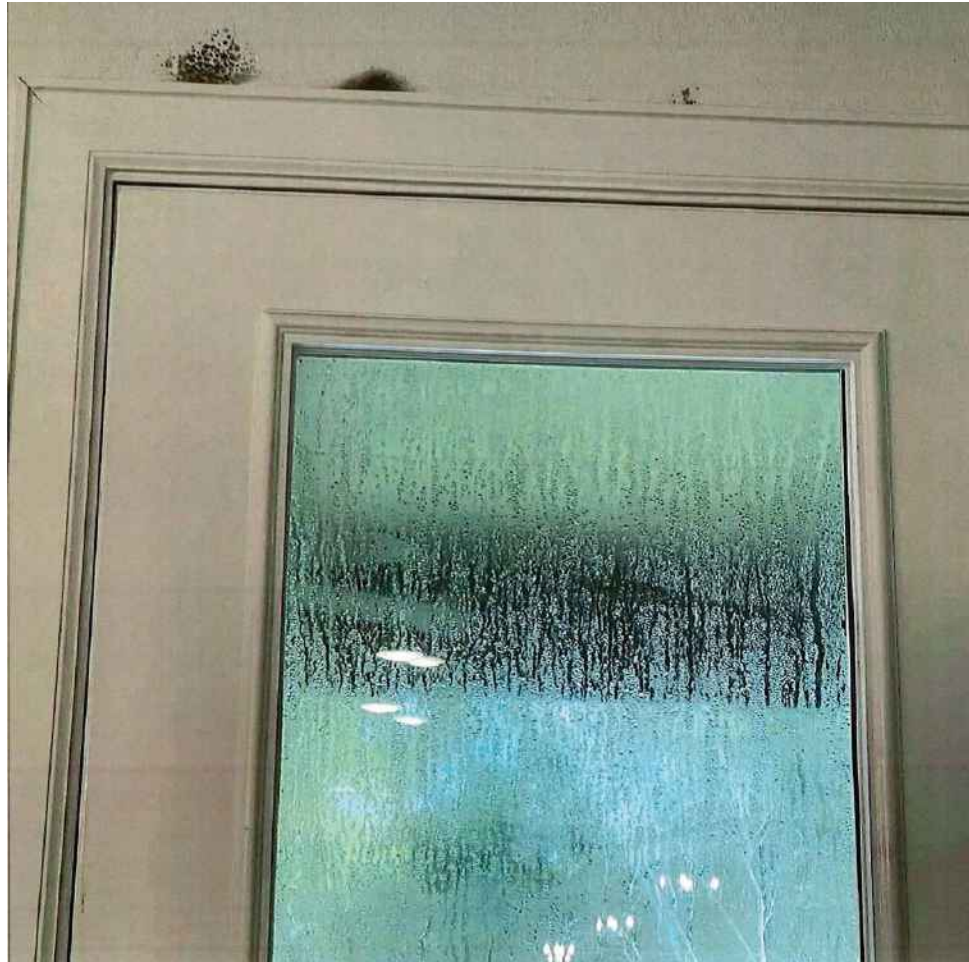
For instance, the homeowner's email dated 5/30/2024 includes a photograph of the rear door at the living room (Figure 11). This figure shows condensation on the outside of the double-pane glass installed in the rear door<sup>21</sup>. This indicates that the interior temperature is so low that – even through a double-pane insulated glass assembly – the outdoor air is condensing on the external glass surface. The importance of this discovery is in what this means for infiltration air: if the air outside will condense on the outer pane of a *dual-pane insulated* window, it will also condense on interior surfaces when they are exposed to acceptable levels of normal outdoor air infiltration.

**Figure 11** Note the lack of distortion in the reflections of the interior lights on this door's window; this indicates that the condensation is outside, not inside, the home.

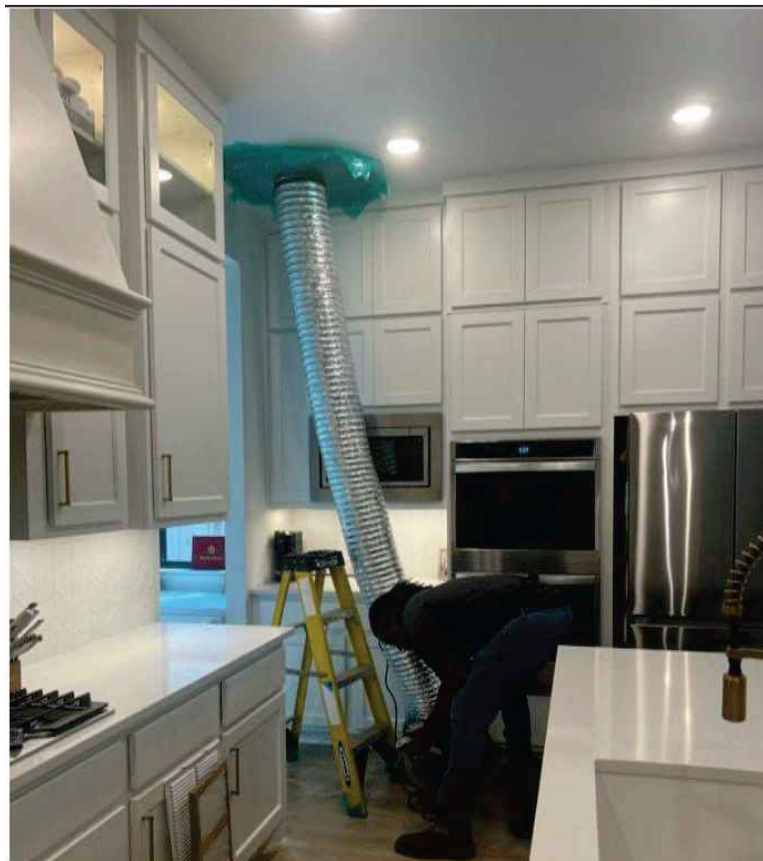
Finally, their photographs suggest that the test was performed incorrectly making the score irrelevant. As shown in Figure 15, the duct pressurization fan appears to have been connected to a return duct in the kitchen. However, this is not a return; it is instead the makeup air duct for the kitchen vent hood. The test as pictured would simply blow air past the duct damper and to the outdoors. This has no connection whatsoever to the HVAC system.

**Figure 15:** This photograph from the Apollo BBC report appears to show a duct pressurization test being performed. However, the connection is to an outdoor vent, not to a return duct of the HVAC system.
