Consultation: Home Evaluation Report

Inspection of Building and HVAC Systems assemblies .

Date | May 31, 2024

Builder/Homeowner | Drees

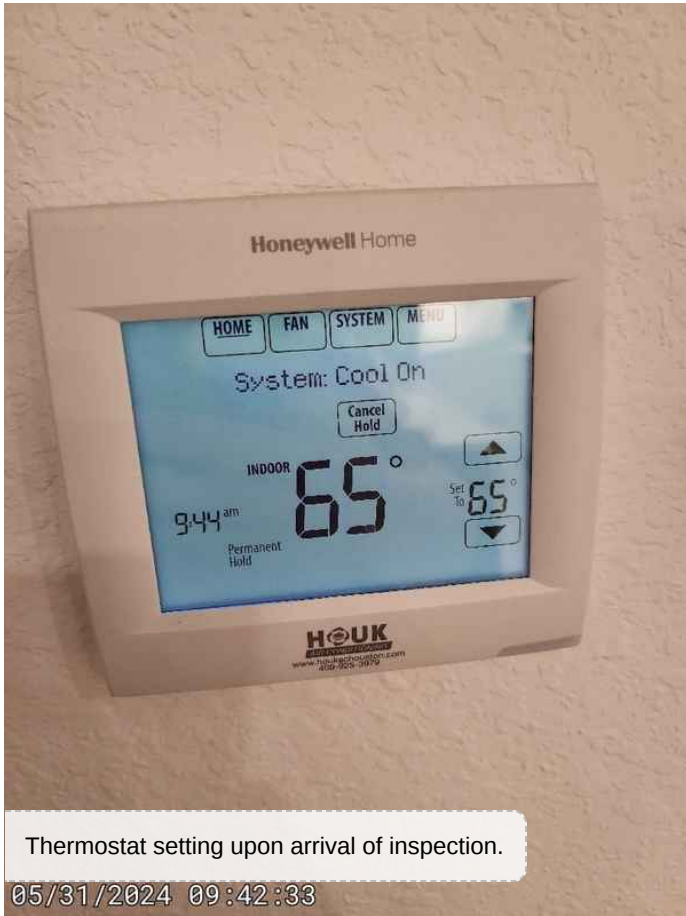
Upon arrival, measured temperature and humidity. Found thermostat set to 65 degrees and satisfied. Humidity was measured at 62 percent. Thermostat fan was set to the "ON" position. This will increase the relative humidity in the home.

Thermostat setting upon arrival of inspection.

Inform homeowner to keep thermostat fan feature in the "auto" position. This will allow the indoor fan to cycle off after temperature is met and reduce indoor relative humidity.

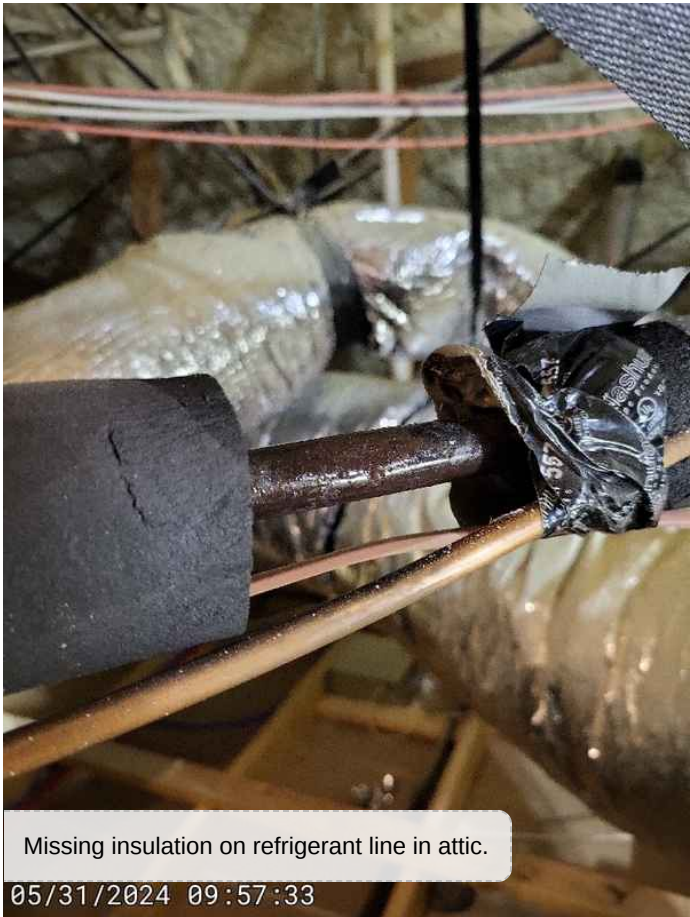
Missing insulation on a small section of the refrigerant line in the attic.

Missing insulation on refrigerant line in attic.

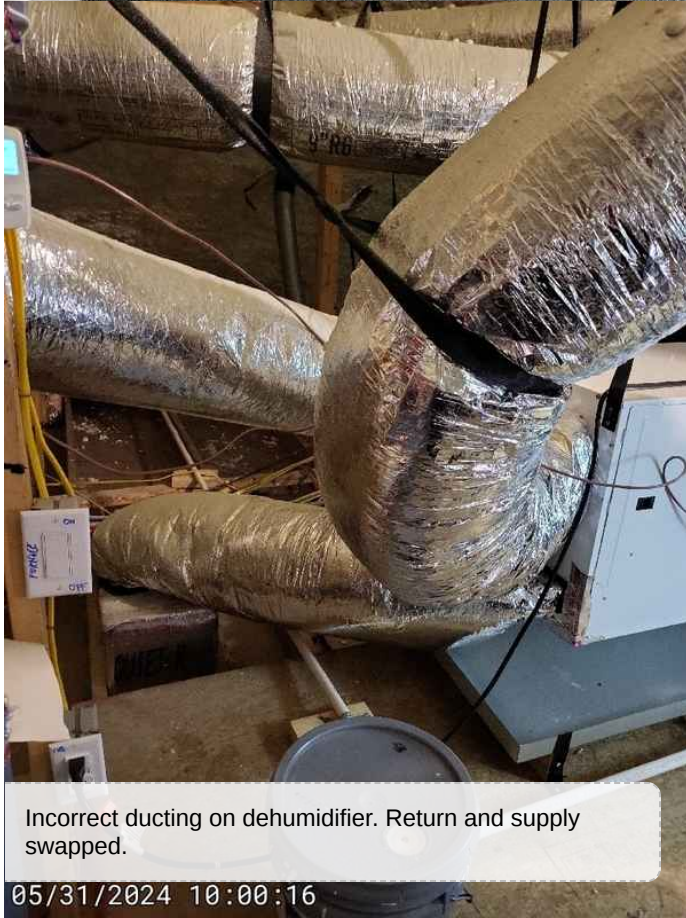
Once in the attic, found the supply and return ducts for the dehumidifier swapped and causing warm air to push out of return near front bedrooms. Controller for the dehumidifier was out of calibration.

Incorrect ducting on dehumidifier. Return and supply swapped.

Reroute supply and return ducts for the dehumidifier. Ensure the backdraft damper for the dehumidifier is installed in the correct orientation after ducting is corrected. Calibrate controller for dehumidifier.

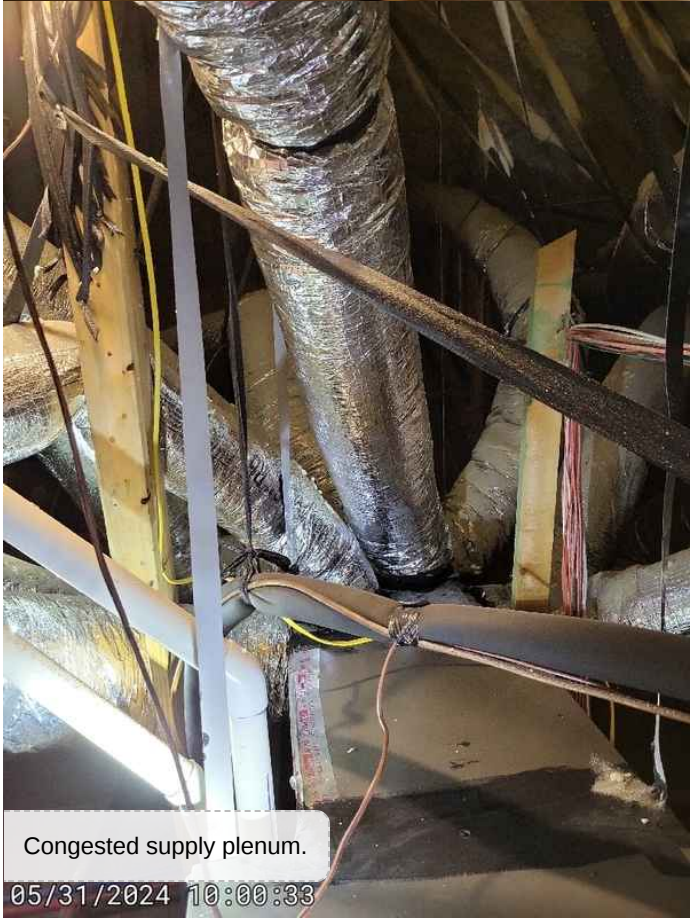
Congested supply plenum.

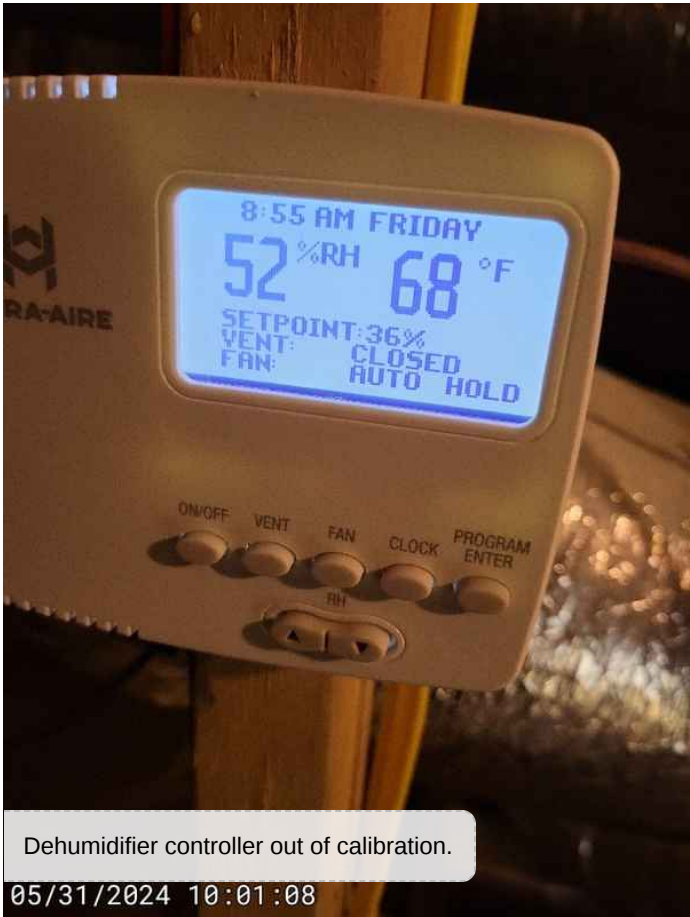
Dehumidifier controller out of calibration.

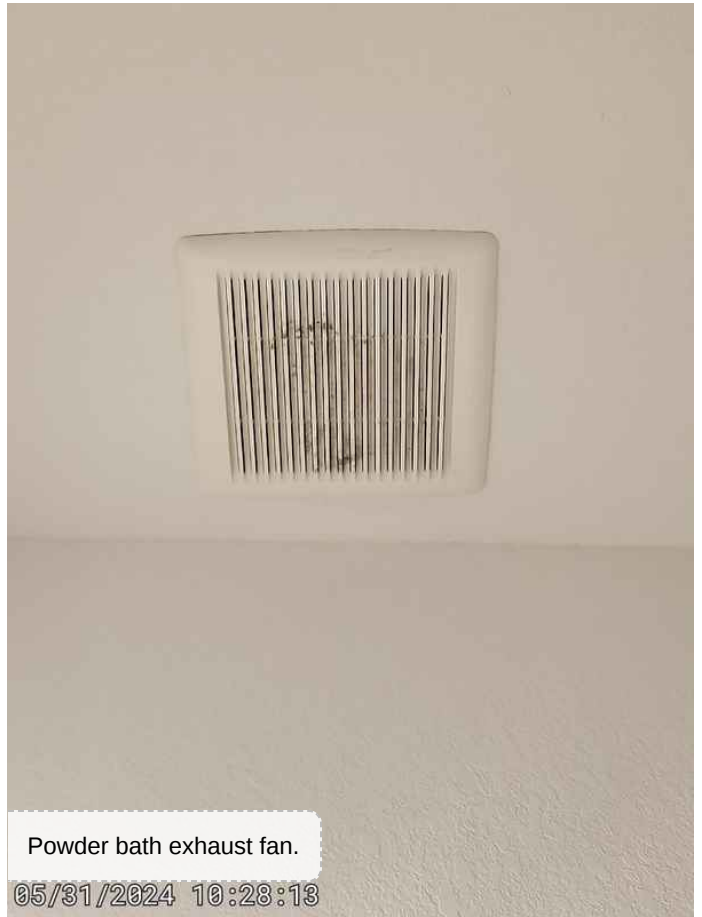
Visual inspections determined several register grills with condensation on them. This is particularly due to the thermostat fan running in the "ON" position. There were signs of biological growth around wet area exhaust fans. With colder indoor temperatures, these fans tend to backdraft and introduce hot, humid air back into the living space providing an environment for bio growth to grow. Only secondary bathroom was observed to have an inline backdraft damper installed.

Powder bath exhaust fan.

Recommended to replace all exhaust fans, housings and ducting. Replace with new and install inline gasketed backdraft dampers wherever the ducting penetrates to the outside.

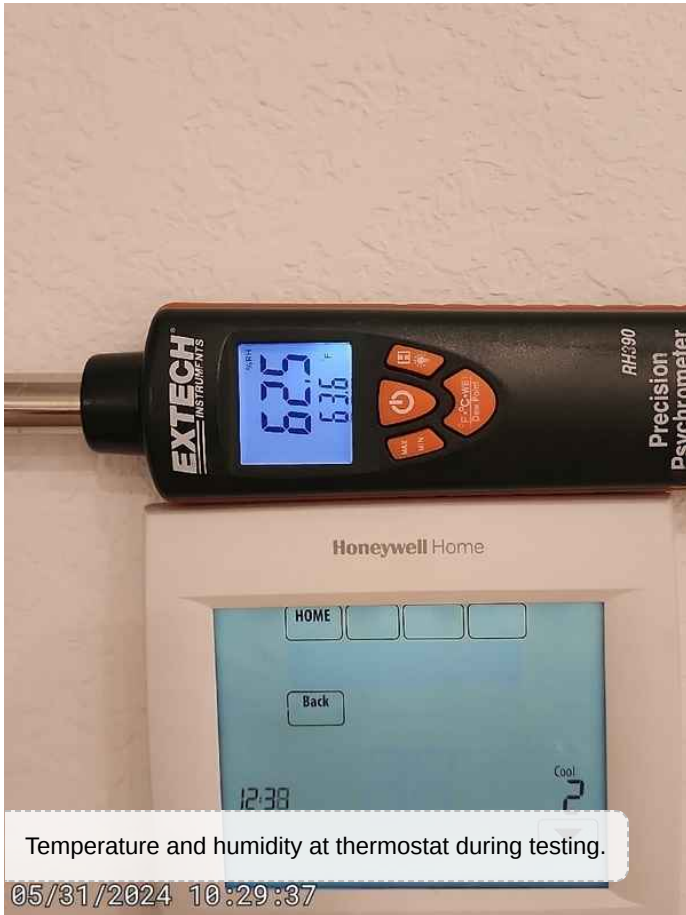
Temperature and humidity at thermostat during testing.

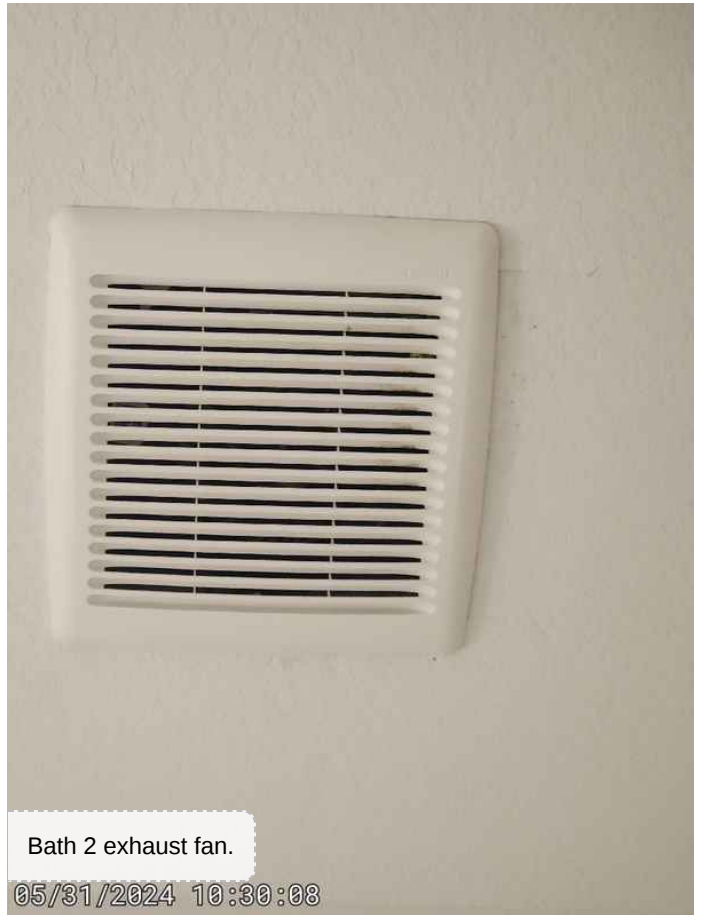
Bath 2 exhaust fan.

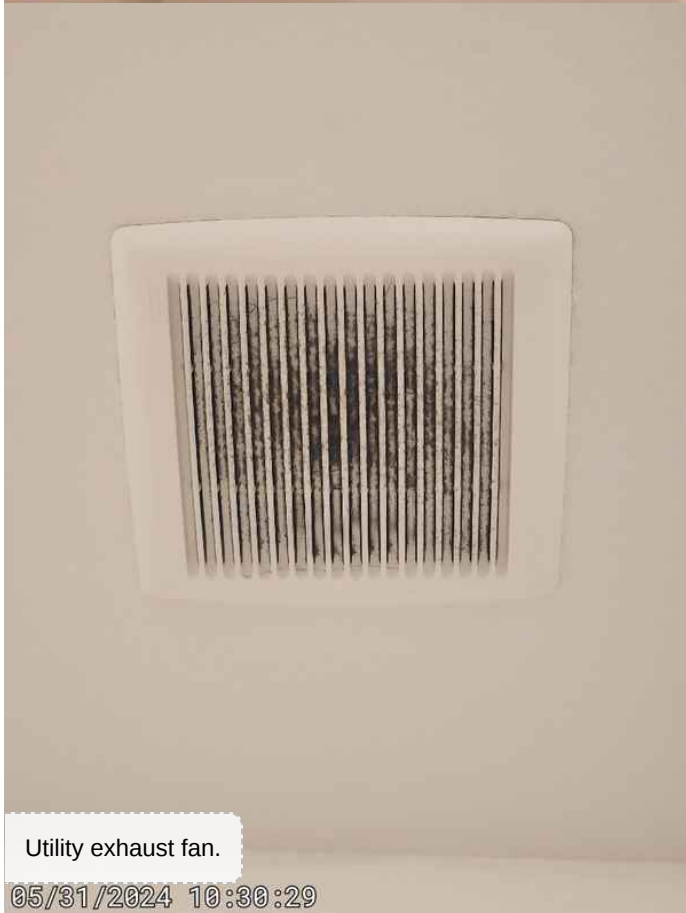
Utility exhaust fan.

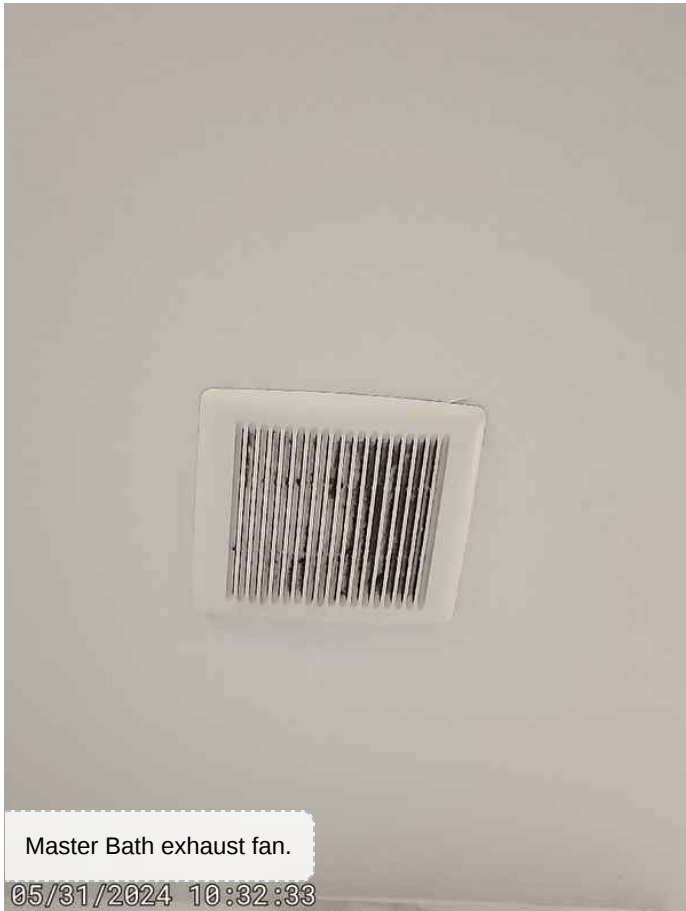
Master Bath exhaust fan.

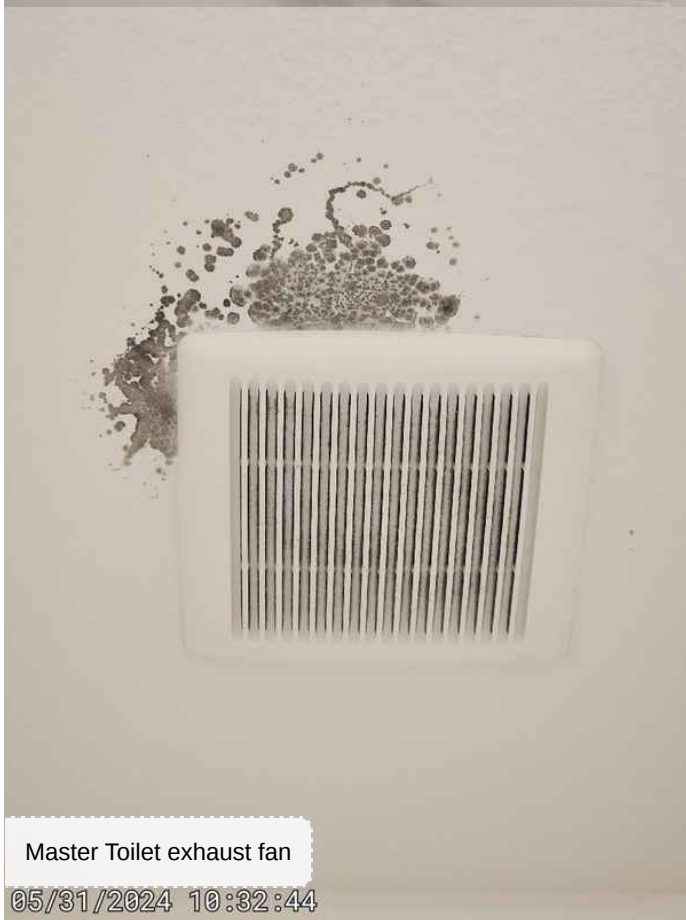
Master Toilet exhaust fan

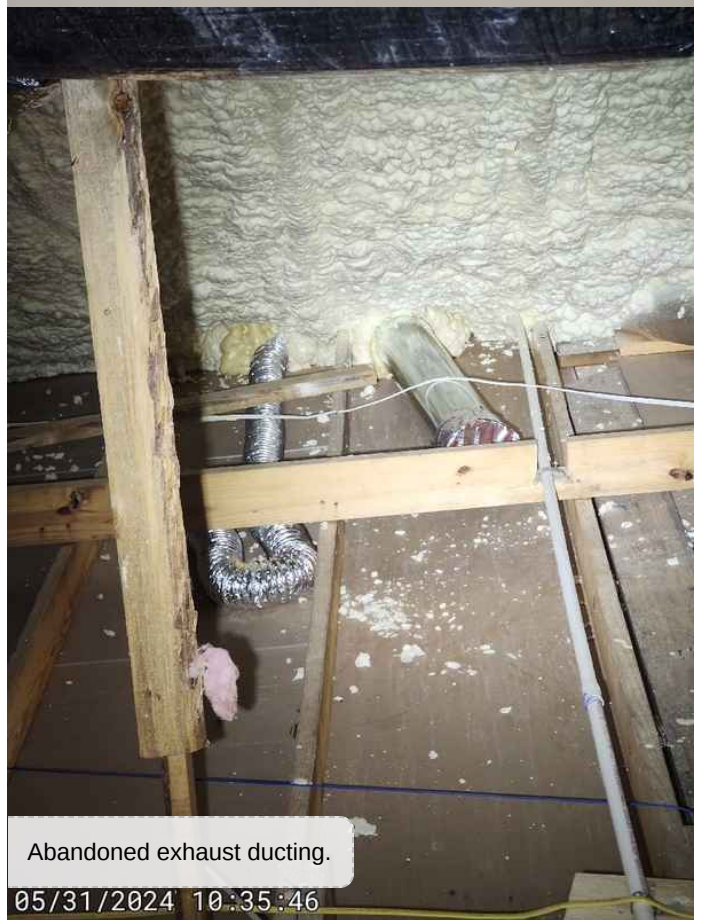
Observed 2 exhaust ducts abandoned in the attic. They are sealed at this time be recommended to be removed.

Abandoned exhaust ducting.

Remove unused exhaust pipes from the attic and seal the exterior penetrations with foam.

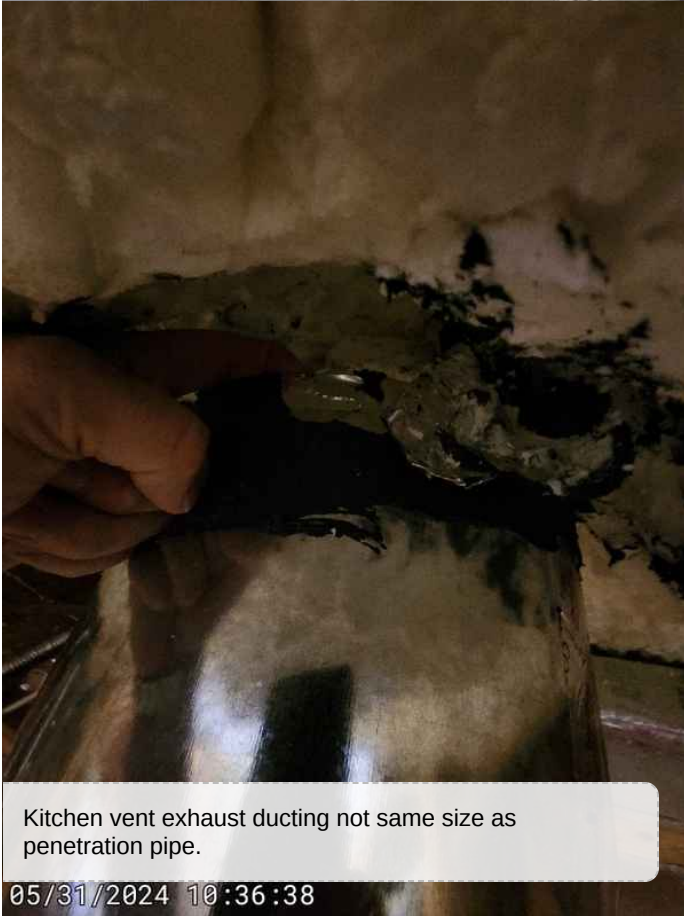
Kitchen vent exhaust pipe is larger than the pipe penetrating the roof. This is resulting in a difficult opportunity to seal pipe correctly. The vent pipe size needs to be consistent from vent fan to exterior termination.

Kitchen vent exhaust ducting not same size as penetration pipe.

Remove current kitchen vent ducting, change roof jack to match kitchen vent size, re install kitchen pipe and install backdraft damper at exterior penetration near roof jack.

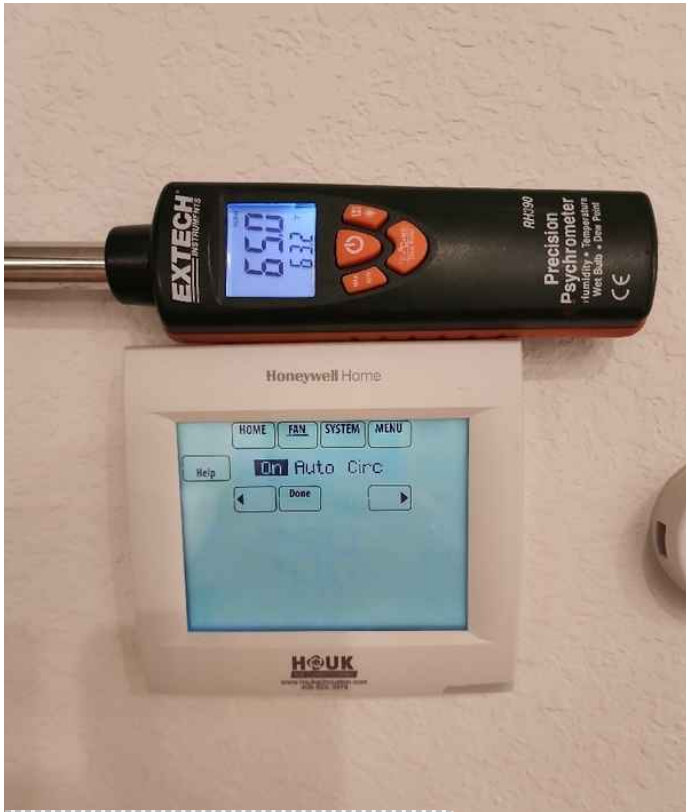
HVAC fan running in the "ON" position.

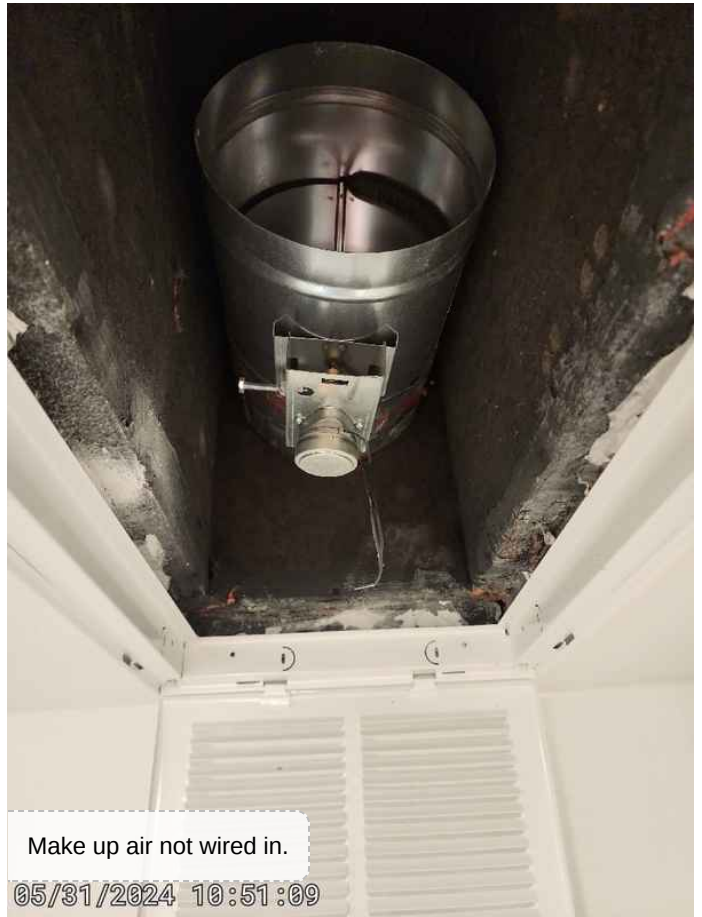
The makeup air for the kitchen vent was not wired in. There should be a device that opens the damper while the kitchen vent is active.
The makeup air damper and duct can be removed entirely if the kitchen vent is under 400CFM.

Make up air not wired in.

Determine if make up air is actually needed. (Only required if hood vent is over 400CFM). If it is in fact needed, a control needs to be installed to operate damper.

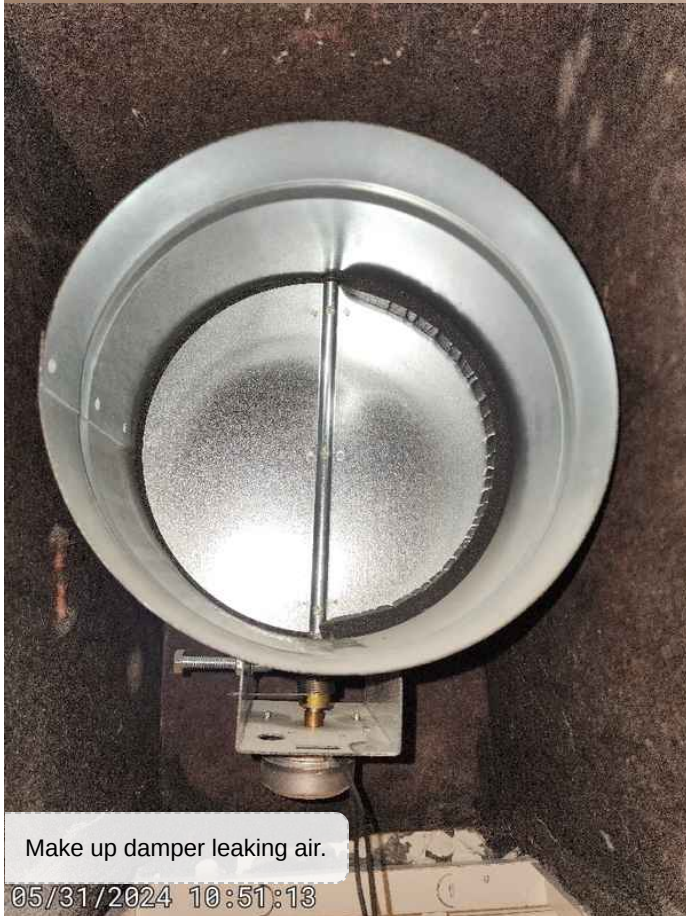
Make up damper leaking air.

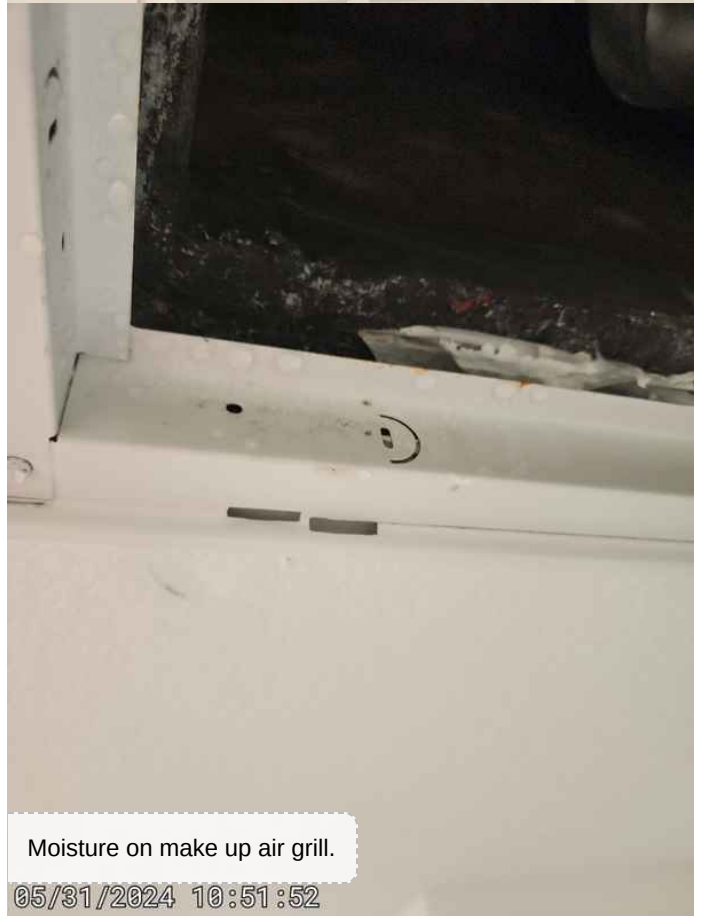
Moisture on make up air grill.
