**Stephen Bourne, Ph.D.**  
**Building Research LLC**  
**PO Box 1188, Crystal Bay NV 89402**

04/15/2025

## **Scope**

Building Research LLC (BRLLC) has been asked to develop a preliminary report for the residence at [REDACTED]. BRLLC visited this home as part of an investigative team on April 4, 2025. The scope of this preliminary report is limited to addressing concerns regarding the building envelope and HVAC systems.

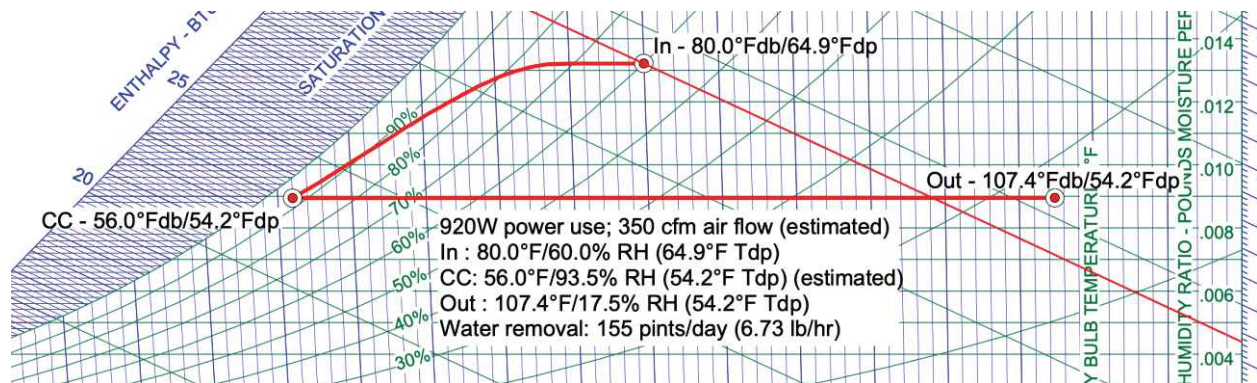
**Figure 4:** A psychrometric chart showing the temperature fall and rise as the air flows through a dehumidifier. Data (except estimated output dew point) is taken from the manufacturer specifications<sup>7</sup> or estimated using standard psychrometric methods.

The EBE report’s concern regarding hot air being supplied to the occupied space by the dehumidifier is inconsequential; this is normal behavior for a dehumidifier.

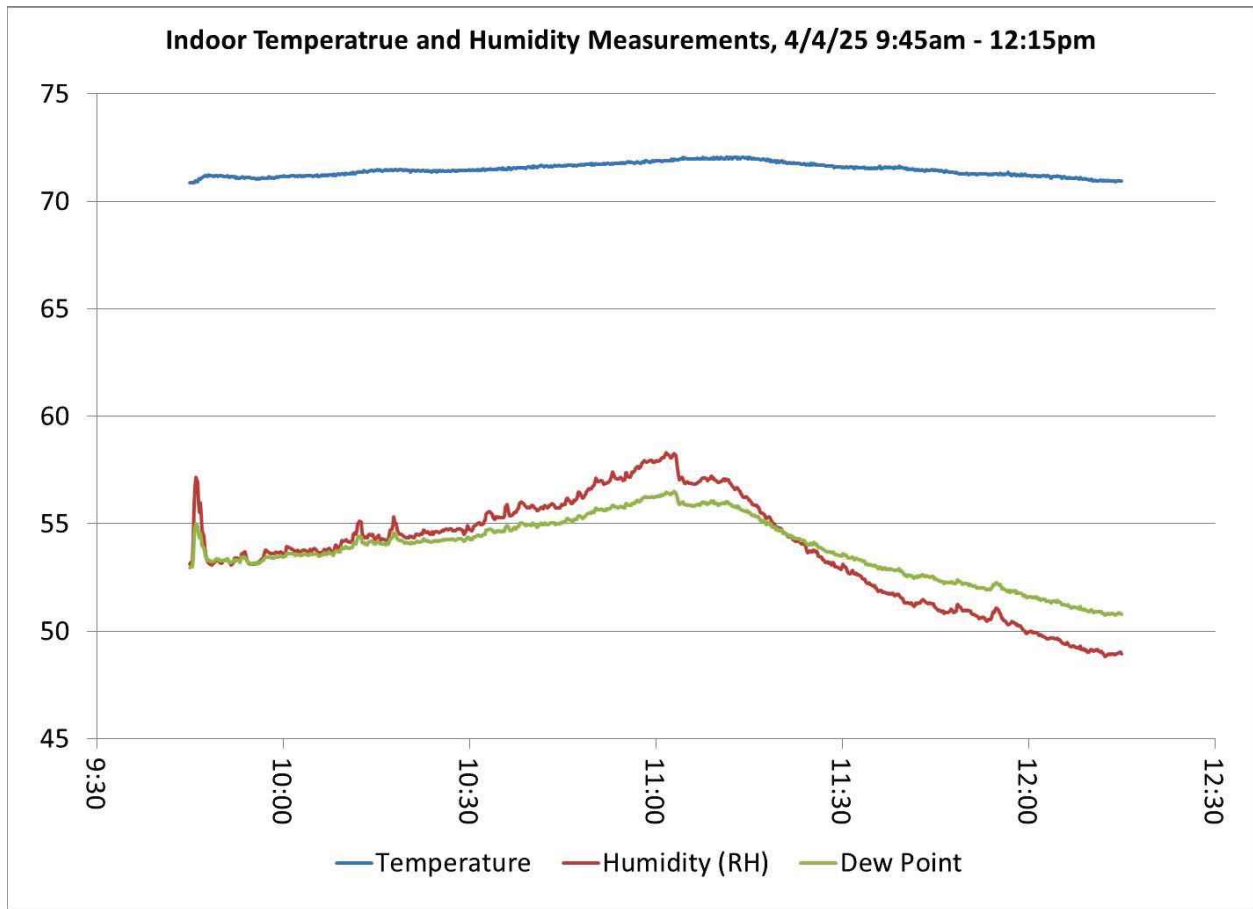
During our testing on 4/4/2025 between the hours of 9:45 am and 12:15 pm, the outdoor temperature ranged from approximately 80°F to 83°F with a relative humidity of between 75% and 65%. During this same time the indoor conditions remained between approximately 71°F to 72°F with a relative humidity of between 58% and 49%. The sealed attic conditions ranged from a temperature of approximately 72°F and 73°F with a relative humidity of between 53% and 58%. The HVAC system and dehumidifier were off for much of the physical inspection, and blower door/duct pressurization tests were run; these actions resulted in a wide range of interior conditions. However, the operational tests later during the inspection show that the HVAC system quickly removed heat and moisture when operating (Figure 5).

No issues were noted with the performance of the system during these tests. The system maintained acceptable temperatures and humidity levels when operating.

**Figure 5:** Temperature and humidity in the home during the inspection on 4/4/2025. Note how the HVAC system rapidly removed humidity from its peak once the system was engaged.

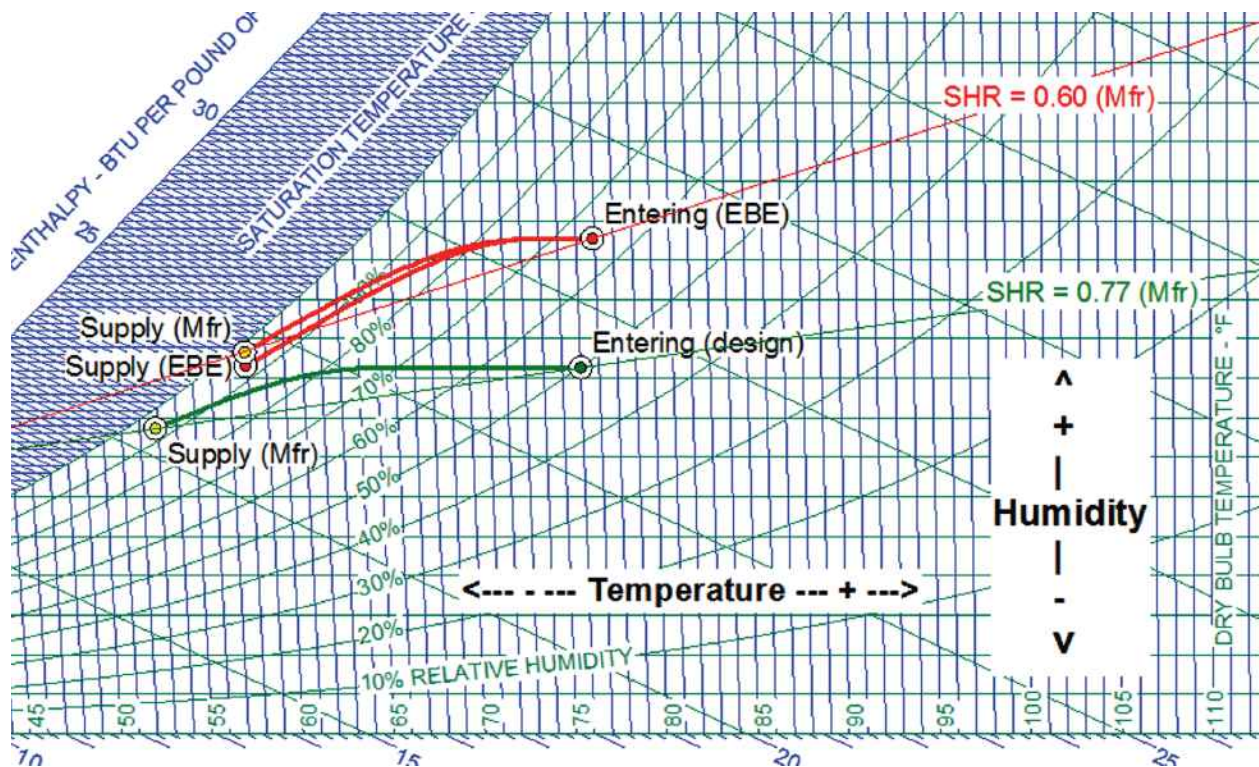
Figure 6 is a psychrometric chart of the conditions identified by EBE during their analysis. Also included is the expected output of the installed equipment under the same input conditions, taken from extended data tables on the cooling system performance provided by the manufacturer<sup>9</sup>. What this chart shows is that the HVAC system is performing *almost exactly as expected for the conditions*. The reason that the temperature is “...not low enough to meet room design conditions...”, i.e., the temperature difference, or “delta”, between the incoming and outgoing HVAC system air flow as alleged by EBE, is the high humidity of the air at the input (return) to the HVAC system.

**Figure 6:** Psychrometric chart showing the actual and expected performance of the HVAC system during the EBE inspection (red lines). Note that the actual and expected performance is nearly identical. The reason for the low delta-T is the high humidity of the air at the input (return) side of the HVAC system.

Vapor compression cooling systems are highly dynamic; they respond as conditions change. In this case the high humidity of the incoming air has resulted in the HVAC shifting its operation towards removing water rather than cooling the air. This is represented by the SHR (Sensible Heat Ratio<sup>10</sup>) of the system shifting downward, as shown by the red diagonal line in Figure 6 marked “SHR = 0.60”. The SHR represents the fraction of the available capacity that is removing “sensible” heat (lowering the temperature of the air); in this case 60% of the available capacity is lowering the temperature of the air, while the remaining 40% is removing heat associated with dehumidification efforts.

Figure 6 also includes a plot (green lines) that predict how this HVAC system would perform (using manufacturer extended coil data) under the code-mandated interior design conditions (75°F/50%RH) and the outdoor conditions recorded by Always Cool on the day of their investigation (84.9°F outdoor dry bulb temperature). The results show that under these conditions the HVAC system would have had a SHR of 0.77, which demonstrates the capacity shift back towards temperature reduction (77% of capacity) and away from humidity removal (23%). Under these conditions the HVAC system would have

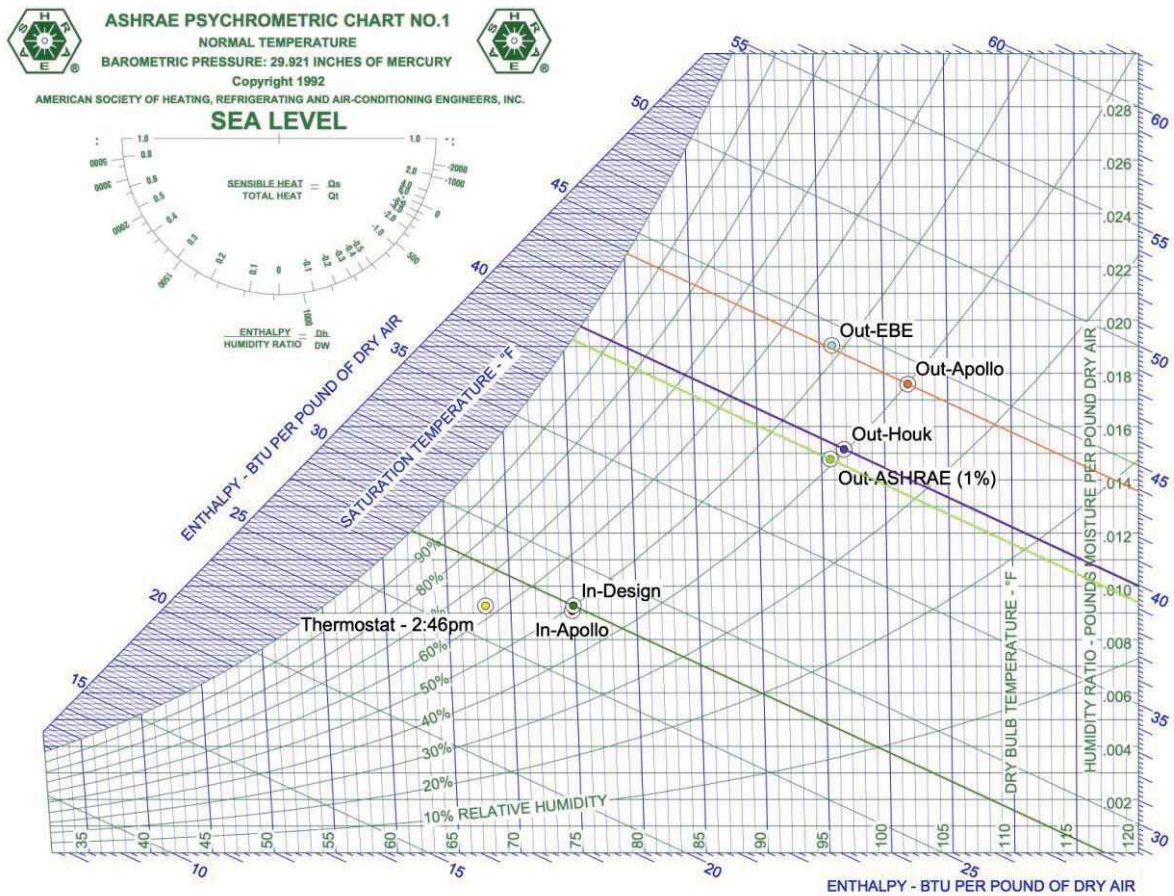
These values are plotted on a psychrometric chart in Figure 8. These show that on the day of the Apollo inspection the total enthalpy<sup>15</sup> of the outdoor air was higher than either the ASHRAE or Houk design values, and approximately equal to the design values used by EBE. This means that the effective

**Figure 8:** This shows the relative state of the outdoor air at design conditions, plus the outdoor and indoor air on the day of the Apollo BBC inspection. Note that the thermostat value is assuming 63% RH.

What this means is that the outdoor conditions during the Apollo BBC inspection met or exceeded the design criteria regardless of which standard is considered<sup>16</sup> – that used by EBE, Houk, or as specified by ASHRAE. And yet on this very warm, humid and sunny day the HVAC system of the home managed to maintain interior design conditions of approximately 75°F at 50% RH. This is empirical confirmation that the system as installed is sufficiently sized for the expected load.

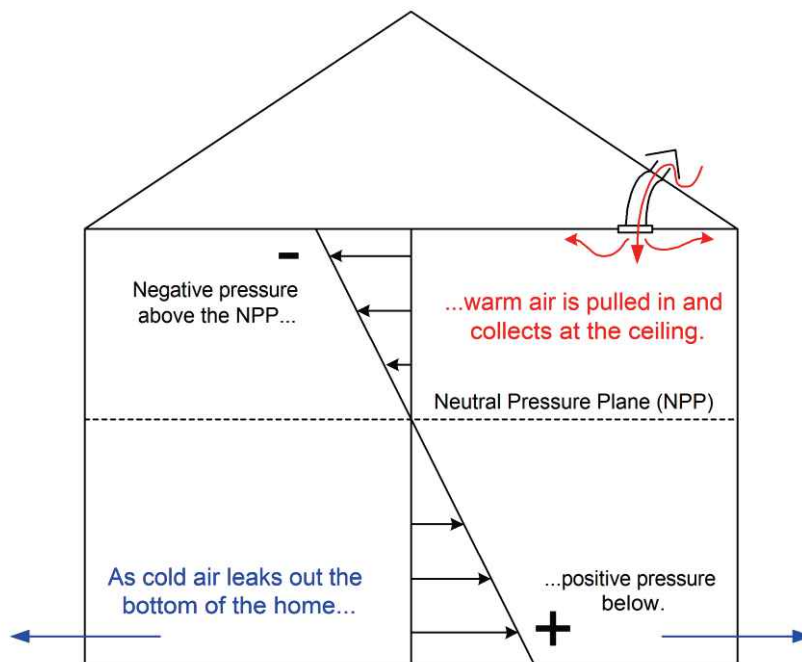
For cases where the condensation is on the face of the supply grill in bathrooms with exhaust vents, the problem is primarily due to low temperature operation. Low temperature operation increases air infiltration as a result of the “stack” effect (Figure 12). The stack effect is a natural phenomenon that occurs when the indoor air temperature differs from the outdoor air temperature. In the summer, the cooler indoor air is denser than the outdoor air; the indoor air tends to “fall” towards the bottom of the home and leak out through low air paths at the base of walls, windows or doors. This results in a negative pressure developing at the ceiling, which in the case of the bathroom exhaust fan causes small amounts of air to “back-draft” into the bathroom from the exhaust fan. When these small amounts of back-drafted outdoor air encounter the cold surface of the supply register it tends to condense water on its surface.

**Figure 12:** A diagram depicting the “stack” effect. Note that in one story homes the stack effect is typically small; however, extreme low temperature for extended periods can lead to back-drafting.

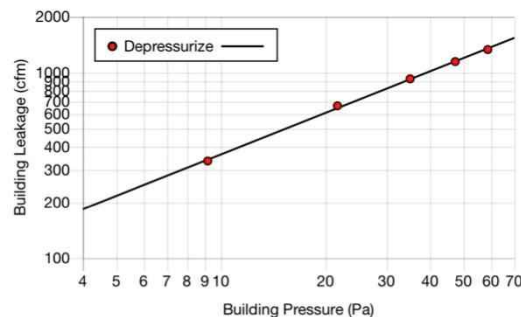
Test ID:	Blower Door 1	
Purpose of Test:	RESNET Multi-Pt Env. Leakage	
Measured CFM50:	1,199.3 (+/- 4.0%)	Effective Leakage Area: 52.2 in <sup>2</sup>
Building Volume:	0.0 ft <sup>3</sup>	Enclosure Surface Area: 0.0 ft <sup>2</sup>
Coefficient (C):	65.7 (+/- 16.0%)	Exponent (n): 0.743 (+/- 0.047)
Correlation Coefficient:	0.99941	
Test Standard:	RESNET 380 Multi-Point	Test Mode: Depressurize
Test Characteristics:	Indoor Temp: 69 °F	Outdoor Temp: 78 °F
	Altitude: 100.0 ft	Time Average Period: 30 seconds
Test Date and Time:	2025-04-04 09:35:38

**Figure 14:** Blower door test results 4/4/2025.
